CASE STUDY ENVIRONMENT HEALTH & SAFETY

THIS CASE STUDY DRAWS ON THE CIRCUMSTANCES RELATED TO A MAJOR FIRE INCIDENT AT THE LENDLEASE BARANGAROO SOUTH CONSTRUCTION PROJECT IN MARCH 2014.

THE BARANGAROO FIRE INCIDENT EVENT

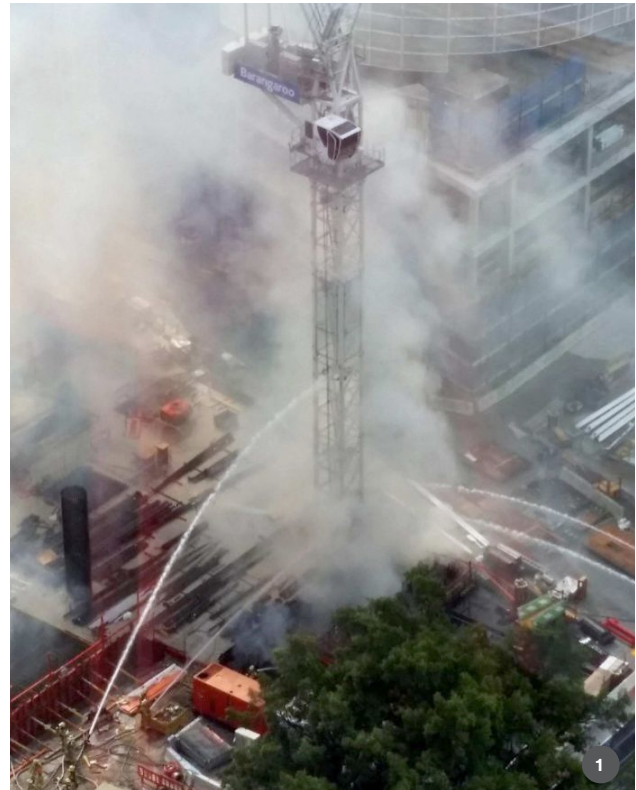
1: NSW Fire & Rescue Crew attempting to extinguish the flames which spread to the base of the tower crane. Source: *Sydney Morning Herald*

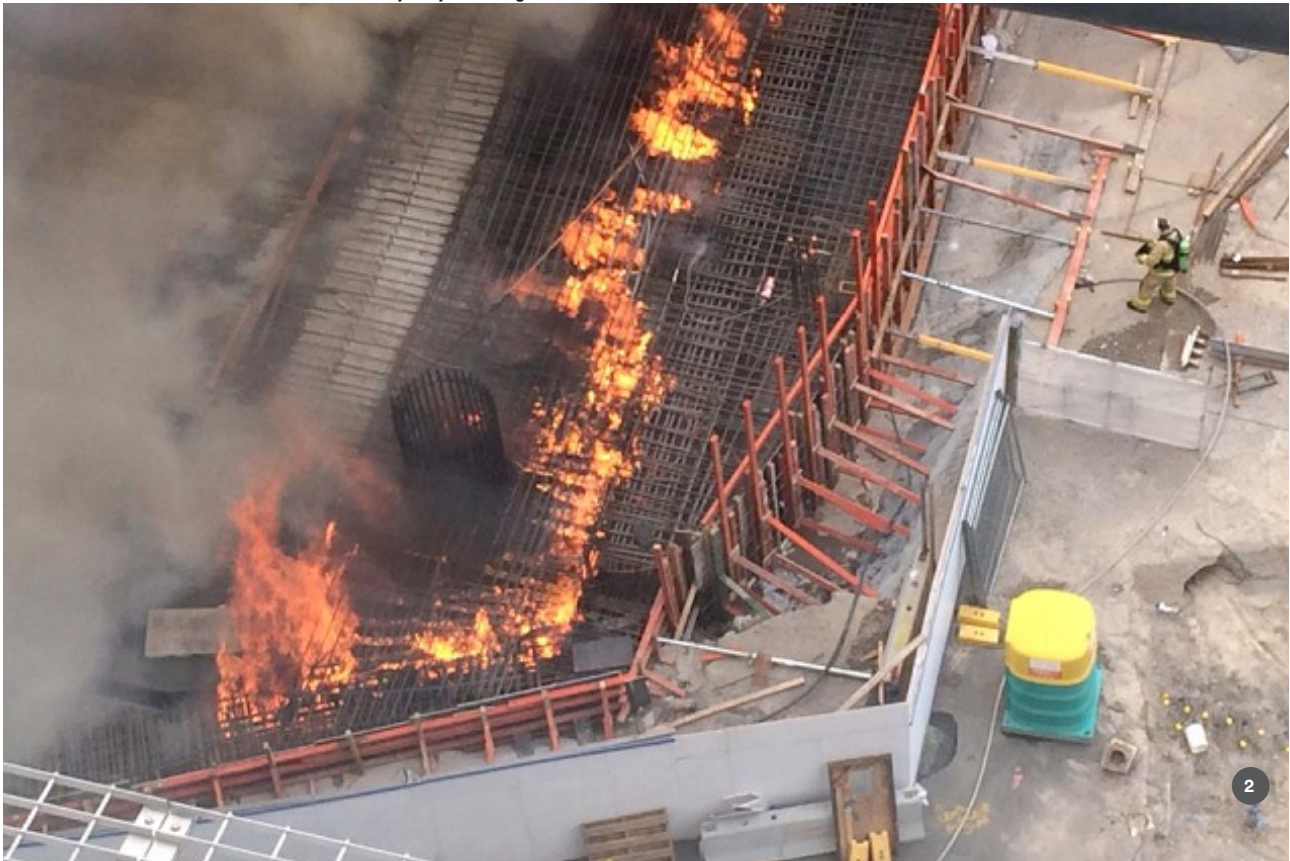
Fire & Rescue NSW attended the scene and their subsequent investigation concluded that hot work being carried out in the proximity of column C3 and combustible material at that point of origin (Column C3) resulted in an accidental fire.

2: Formwork and flammable materials on fire surrounding the C3 Column and the extent of the fire around the column, which extended to the basement below. Source: *Sydney Morning Herald*

- Refresher training in permit to work implementation and first attack fire response for those undertaking hot works and those supervising such works.
- Consideration of design of large column steel reinforcement cages (e.g. 1,600mm or more in diameter) and the location of steel stiffening rings along the column's length (for transport and lifting), to prevent any clash with the stiffening rings and the desired horizontal steel reinforcement installation at a slab level.
- Use of pneumatic cutting tools to prevent hot works around timber formwork and other combustible materials.

- Consideration of fire-retardant properties in the design of column form tubes.
- Building Code of Australia E1.9 requirements for operational fire risers and hose reels provided for buildings/structures greater than 12m and maintained two storeys below the effective height of the building/structure.
- The process for assessing design change for any new or alternative products proposed within major subcontractor packages.
- Training of site personnel in emergency response planning.
- Evacuation drills and the use of credible scenarios to test emergency preparedness and identify improvement opportunities and training.
- Worker education on emergency evacuation and the importance of presenting to the evacuation assembly area to enable each worker to be accounted for.
