## CASE STUDY ENVIRONMENT HEALTH & SAFETY

### THIS CASE STUDY DRAWS ON THE CIRCUMSTANCES RELATED TO A MAJOR FIRE INCIDENT AT THE LENDLEASE BARANGAROO SOUTH CONSTRUCTION PROJECT IN MARCH 2014.

#### THE BARANGAROO FIRE INCIDENT EVENT

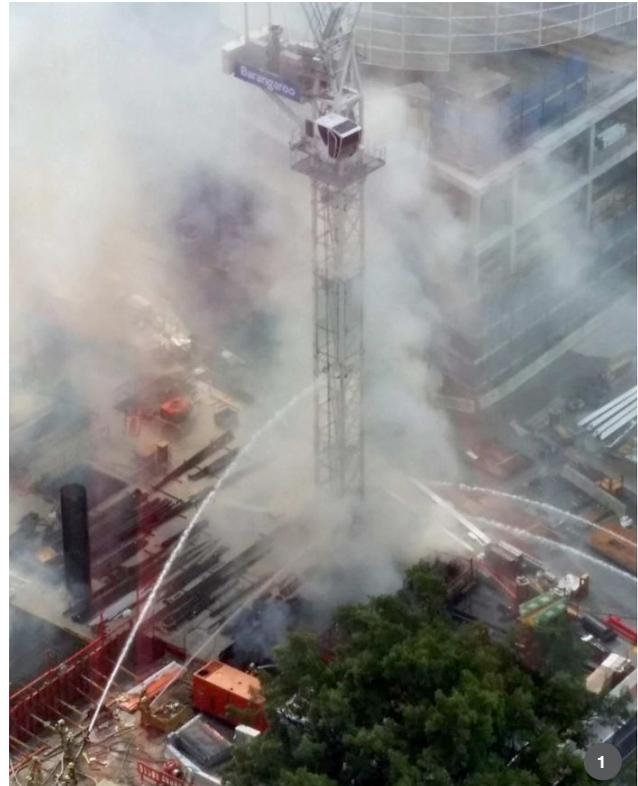
1: NSW Fire & Rescue Crew attempting to extinguish the flames which spread to the base of the tower crane. Source: Sydney Morning Herald

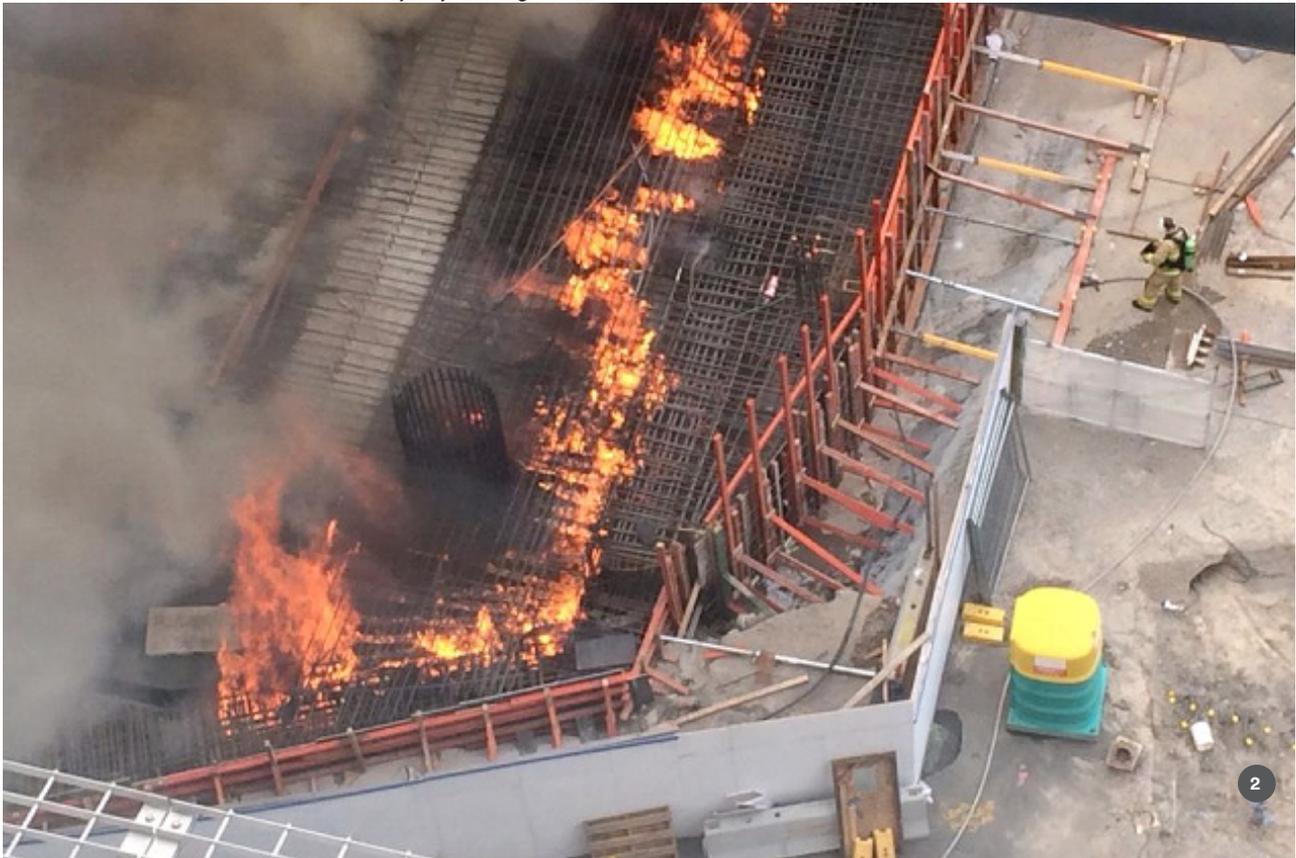
On the 12th March 2014 at approximately 2.00pm a fire occurred within an area of the Barangaroo South Project Tower 3 construction project known as column C3. Around the time of the fire steel reinforcement installation works were being undertaken at ground floor level around column C3. The fire caused extensive damage to the ground floor area of the construction project and to its basement levels.

Fire & Rescue NSW attended the scene and their subsequent investigation concluded that hot work being carried out in the proximity of column C3 and combustible material at that point of origin (Column C3) resulted in an accidental fire.

2: Formwork and flammable materials on fire surrounding the C3 Column and the extent of the fire around the column, which extended to the basement below. Source: Sydney Morning Herald

- Refresher training in permit to work implementation and first attack fire response for those undertaking hot works and those supervising such works.
- Consideration of design of large column steel reinforcement cages (e.g. 1,600mm or more in diameter) and the location of steel stiffening rings along the column's length (for transport and lifting), to prevent any clash with the stiffening rings and the desired horizontal steel reinforcement installation at a slab level.
- Use of pneumatic cutting tools to prevent hot works around timber formwork and other combustible materials.

- Consideration of fire-retardant properties in the design of column form tubes.
- Building Code of Australia E1.9 requirements for operational fire risers and hose reels provided for buildings/structures greater than 12m and maintained two storeys below the effective height of the building/structure.
- The process for assessing design change for any new or alternative products proposed within major subcontractor packages.
- Training of site personnel in emergency response planning.
- Evacuation drills and the use of credible scenarios to test emergency preparedness and identify improvement opportunities and training.
- Worker education on emergency evacuation and the importance of presenting to the evacuation assembly area to enable each worker to be accounted for.
